# Second Breakdown in Germanium Gold-Bonded Diodes

Naval Ordnance Laboratory

SECOND BREAKDOWN IN GERMANIUM GOLD-BONDED DIODES

NOLTR 72-56

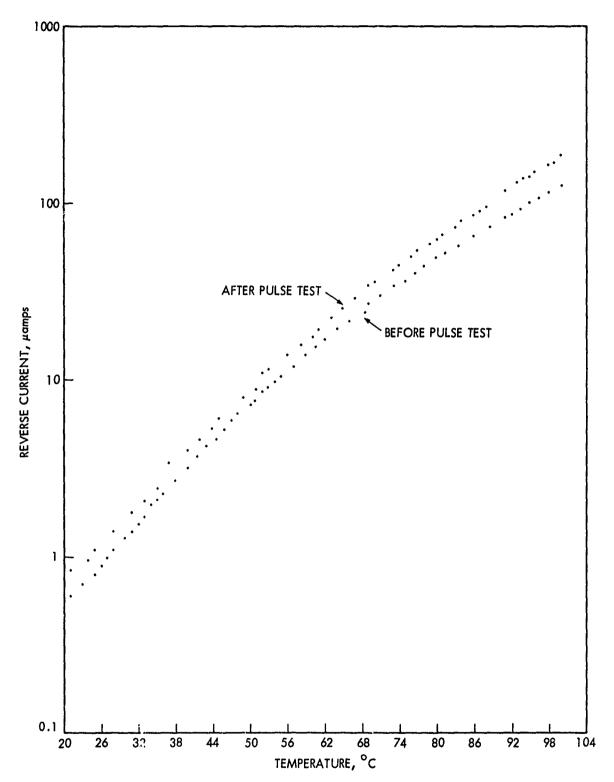
TEMPERATURE MEASUREMENTS. Before and after pulsing, several units were tested to determine the reverse current as a function of temperature at a constant one volt reverse bias. Figure 8 shows the results. The most striking feature is that the two curves are approximately parallel when the current is plotted on a logarithmic scale. Thus at all temperatures tested the current at one volt reverse bias after pulsing is larger than the current before pulsing by a constant multiplicative factor of 1.3.

FIG. 8 REVERSE CURRENT VS. TEMPERATURE AT 1 VOLT BIAS

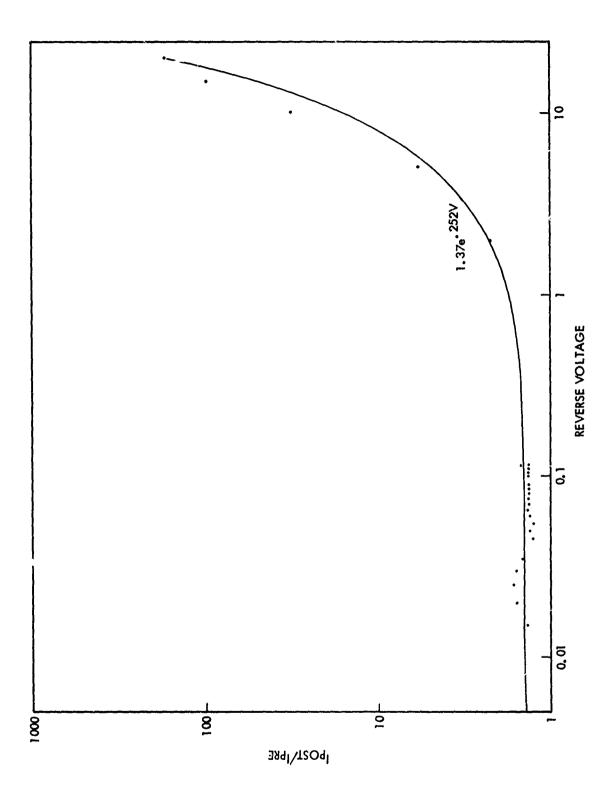
where  $I_2$  and  $I_1$  are the currents after and before pulse induced damage, and V is the voltage across the diode. The fit is excellent from one millivolt to 20 volts, at which point the exponential function increases much more rapidly than the current ratio. This is due to the voltage drop in the bulk of the diode. The curve is shown in Figure 9. The slow variation of the

FIG. 9 (IR POST-PULSE/IR PRE-PULSE) VS. REVERSE VOLTAGE. EXPERIMENTAL POINTS AND LEAST SQUARES FIT CURVE (SOLID LINE).

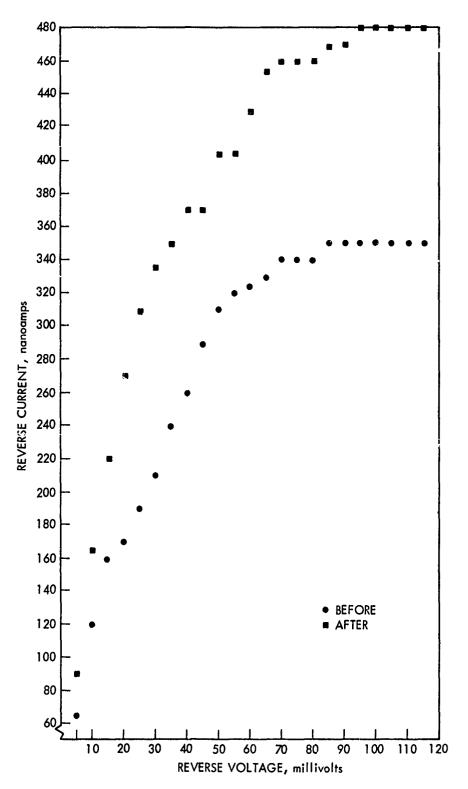
conduction does not begin before the application of approximately two volts forward bias. Nor can the parallel resistance explain the phenomenon shown in Figure 10, where we show the reverse current-voltage characteristic before and after damage. In both cases there exists a range of constant current with varying voltage\*, i.e., dI/dV = 0. With a parallel resistance the current would always be expected to increase at least linearly with voltage. Finally, as shown in Figure 9, the ratio of reverse currents before and after damage varies exponentially with the applied voltage over five decades. Such behavior is hardly characteristic of a shunt resistance. Thus the addition of ohmic resistances is clearly unable to explain the experimental observations.

FIG. 10 LOW CURRENT-VOLTAGE TEST, BEFORE AND AFTER PULSE TEST
